Prepared For
Facilities Management Department
Manatee County Government
Bradenton, FL

Preservation Plan
for the
Crosley Carriage House
(Garage and
Servant's Quarters)

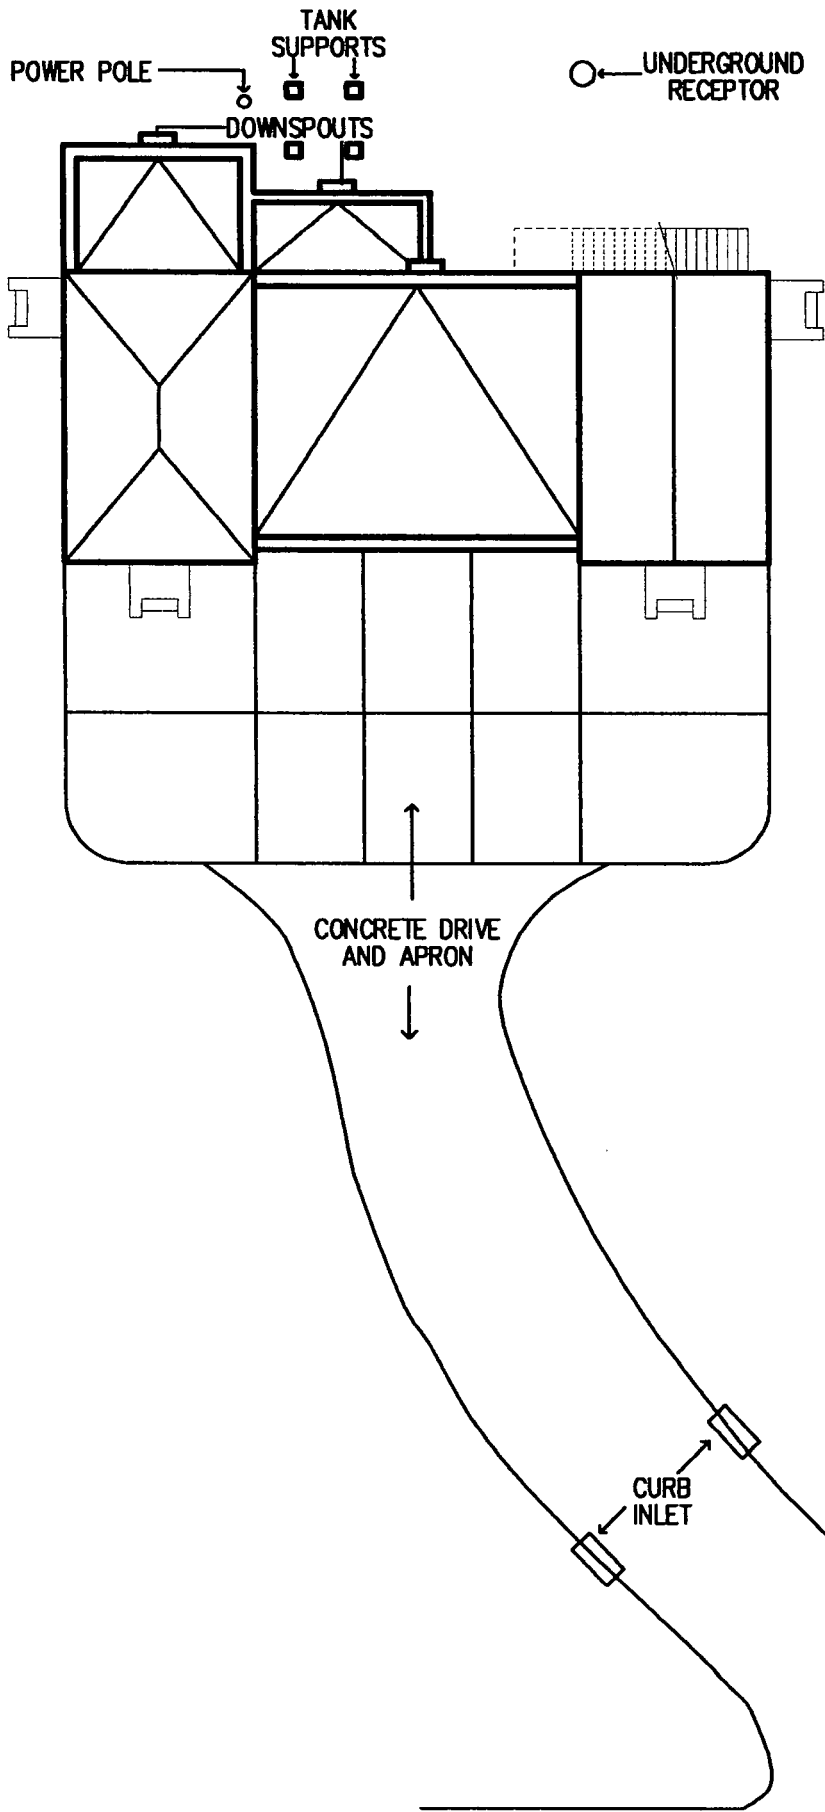
PRESERVATION PLAN
GARAGE AND
SERVANTS' QUARTERS
THE POWEL CROSELY MUSEUM
SARASOTA, FLORIDA

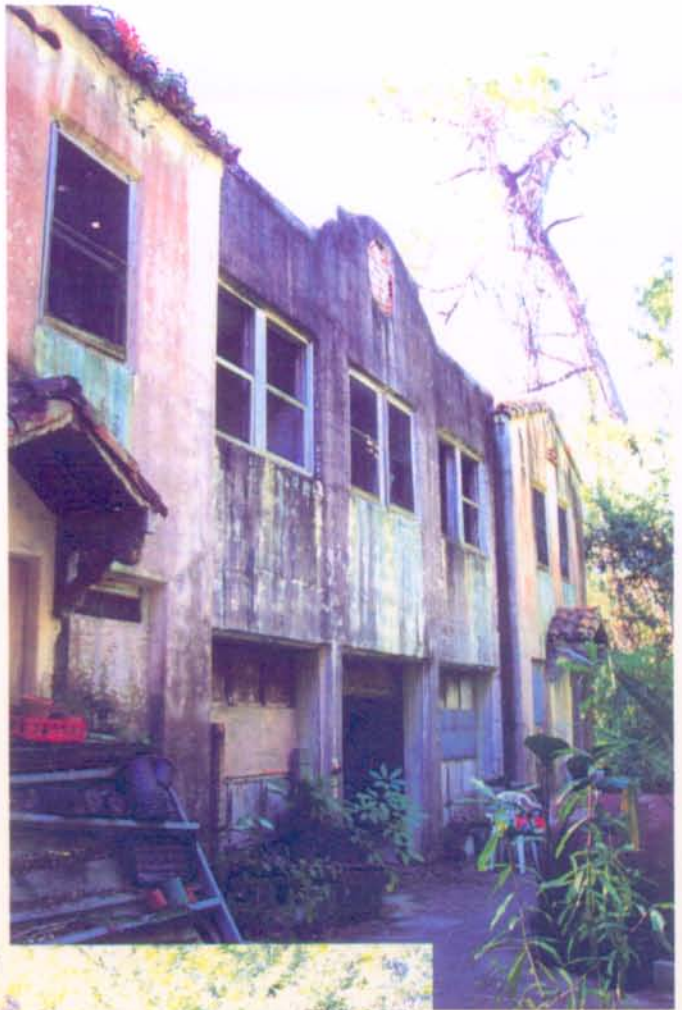
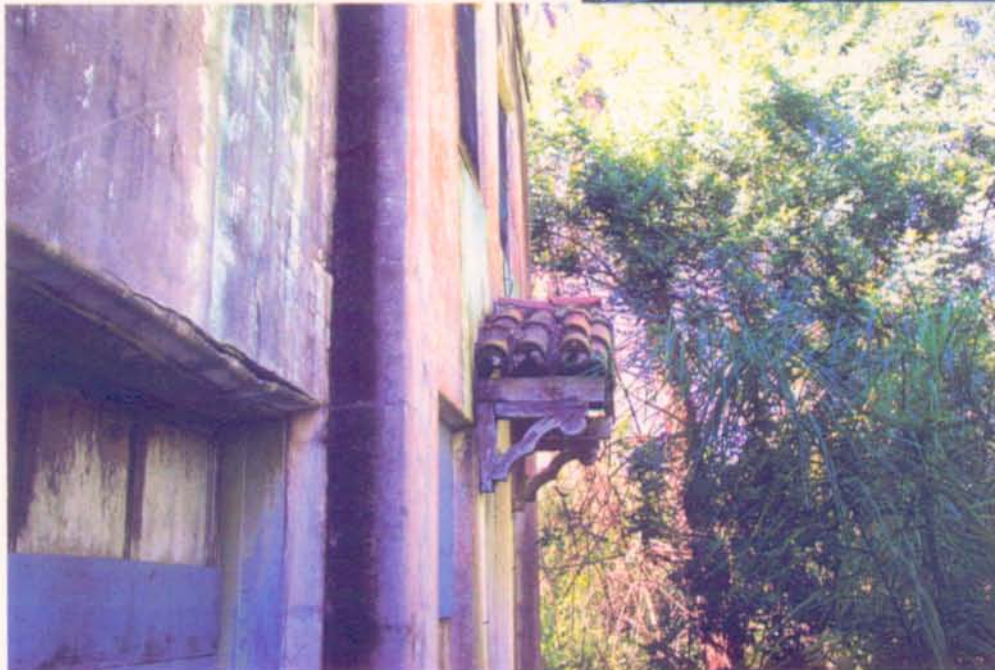
Photograph 2: DETAIL OF PARTIAL NORTH ELEVATION SHOWING HOOD
OVER ENTRY DOOR WITH TILE ROOF.

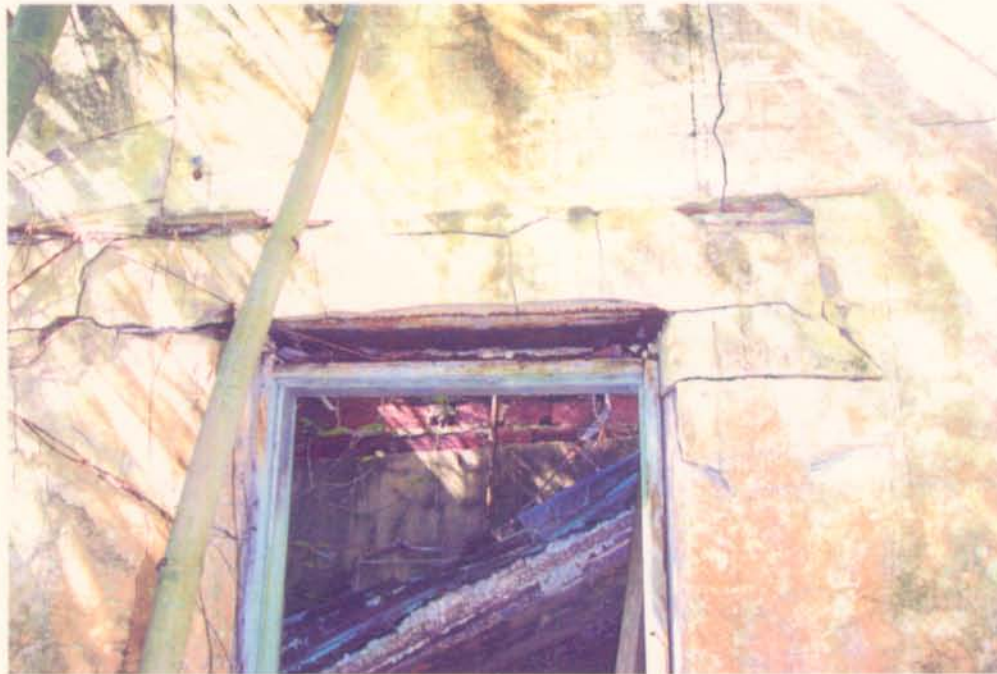
Photograph 4: DETAIL OF PARTIAL EAST ELEVATION WITH DOOR TO LAUNDRY SHOWING DETERIORATED STUCCO AND METAL LINTEL OVER DOOR.

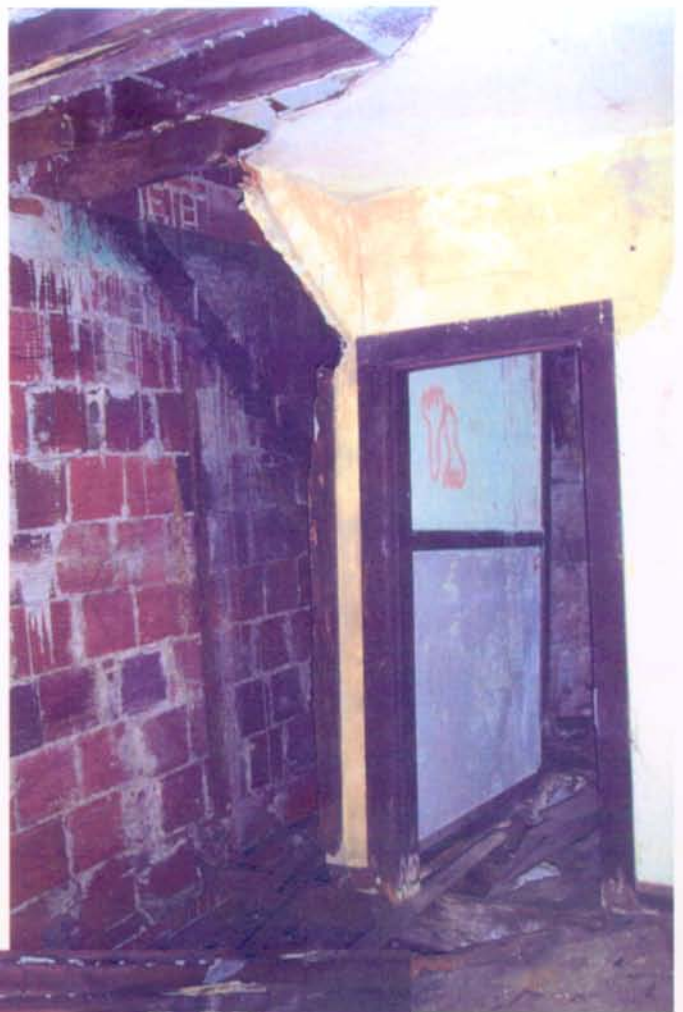
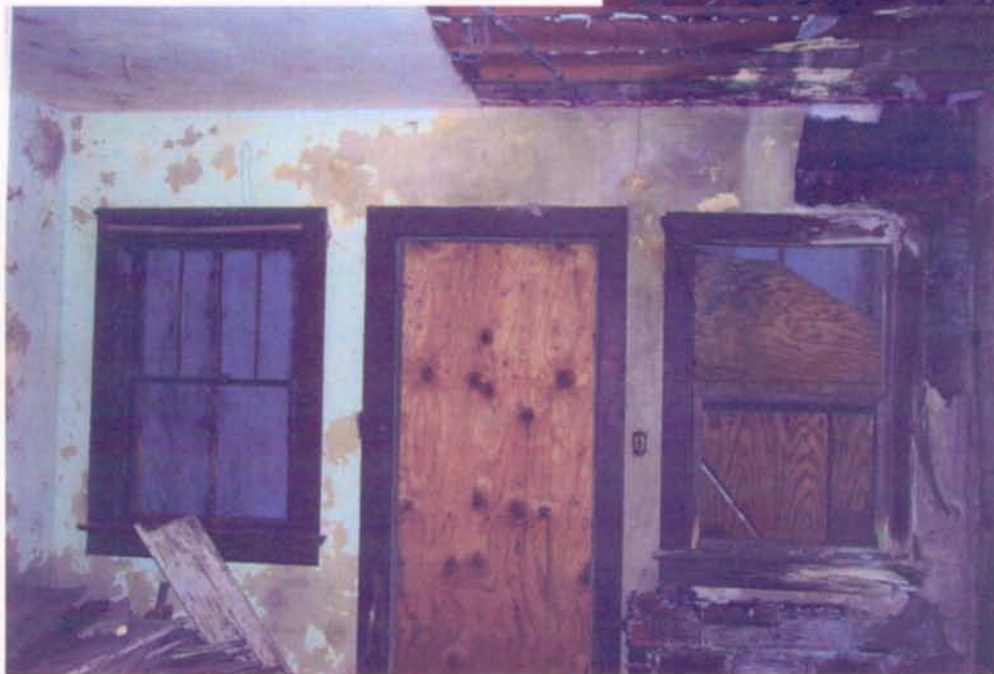
Photograph 8: INTERIOR ELEVATION OF NORTH WALL OF FIRST FLOOR LIVING ROOM.

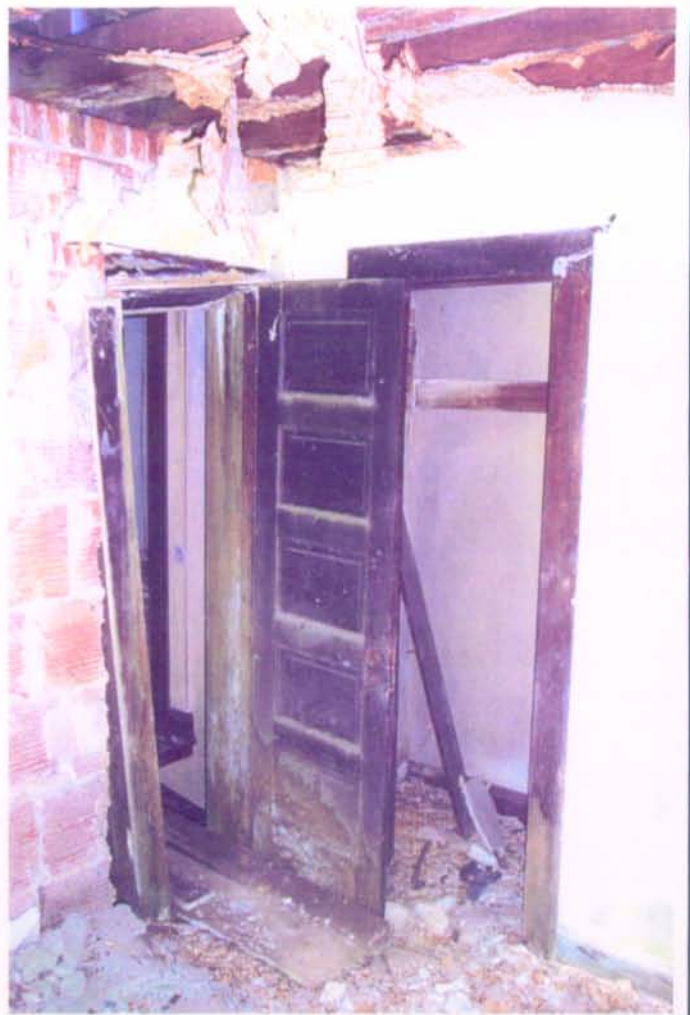
Photograph 11: INTERIOR ELEVATION OF DOOR AND CLOSET ON SECOND FLOOR SHOWING DETERIORATED CONDITION.

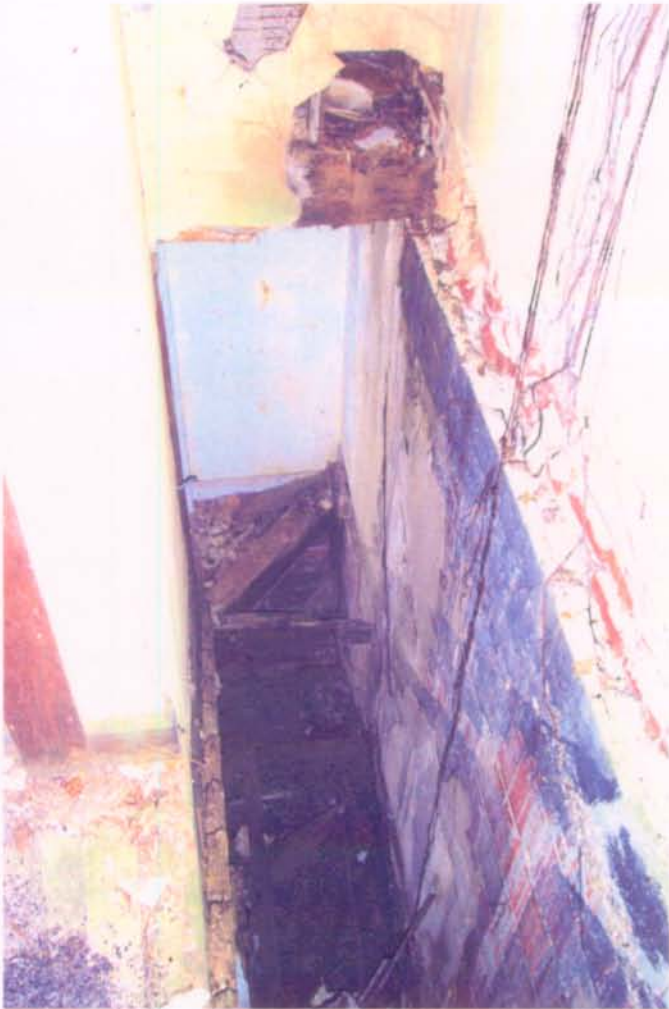
Photograph 12: VIEW FROM SECOND FLOOR LOOKING DOWN INTO STAIR WELL WITH MISSING STAIR.

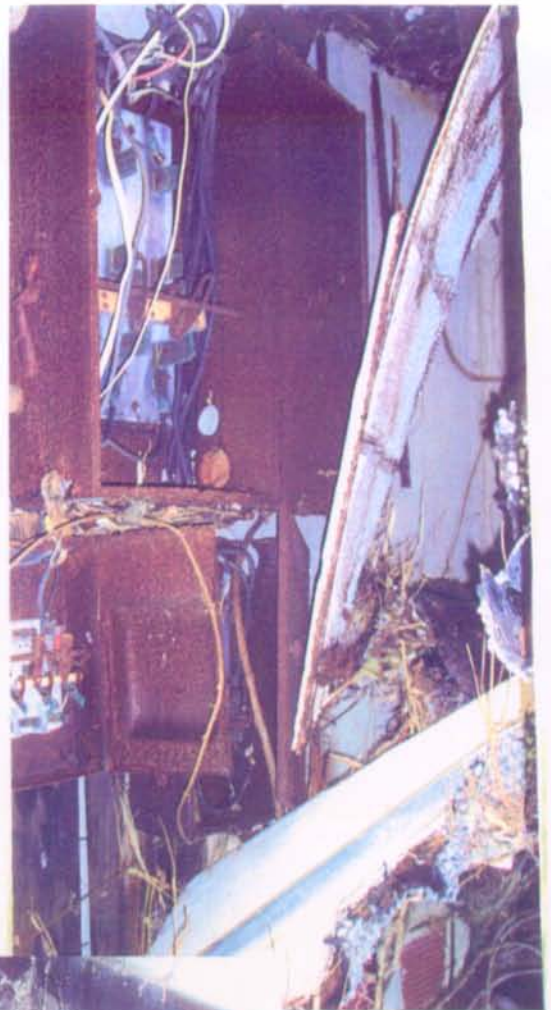
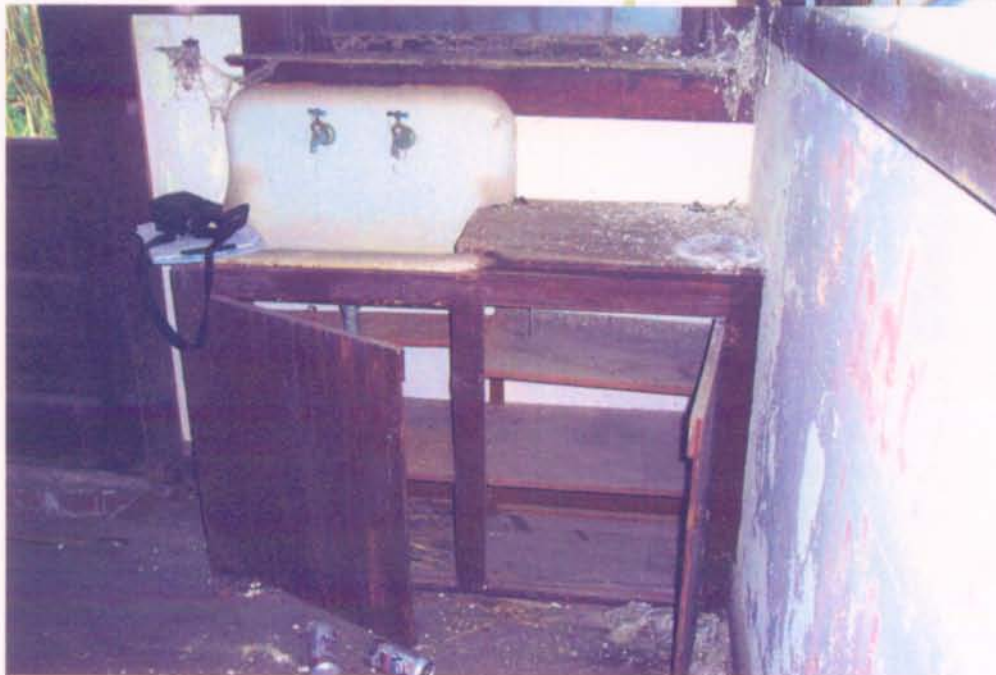
Photograph 14: DETAIL OF ORIGINAL SINK AND BASE CABINET IN WEST UNIT KITCHEN.

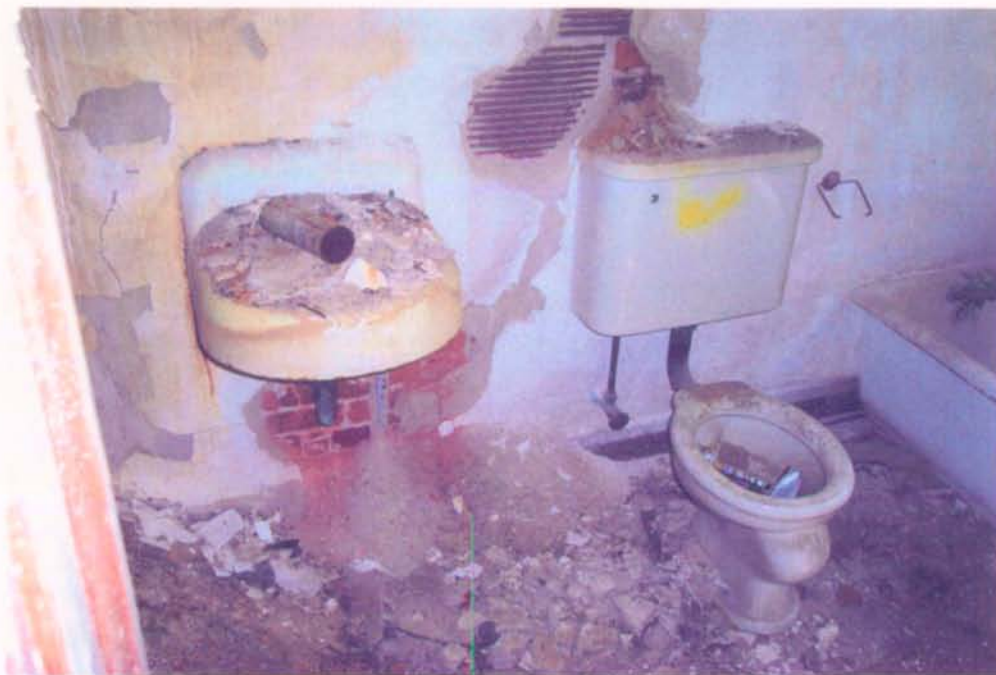
Photograph 18: DETAIL OF BATHROOM SHOWING FIXTURES AND GENERAL DETERIORATION.

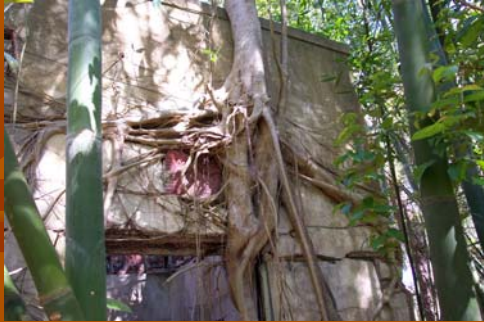
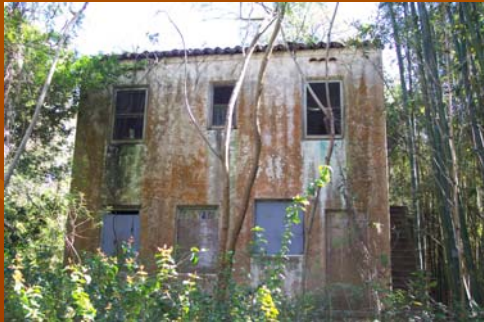
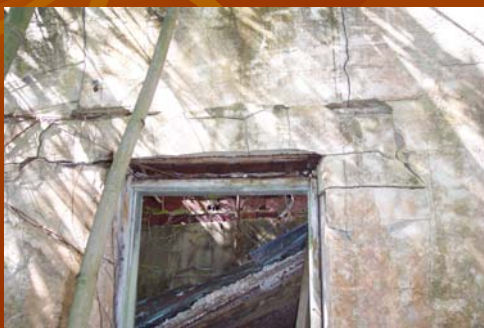
- Introduction of Renker Eich Parks Architects
- Steps in the Process
The Secretary of the Interior's Guidelines
- The Preservation Plan Report
 - History
 - Building Use
 - Condition Assessment and Recommendations
 - Code Analysis
 - Probable Costs
- Question and Answer

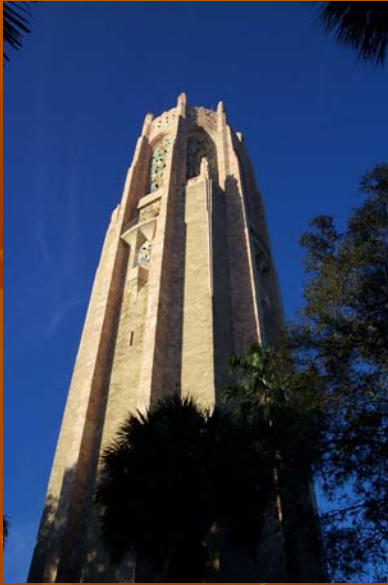
Bok Tower
Lake Wales, Florida
A National Historic Landmark

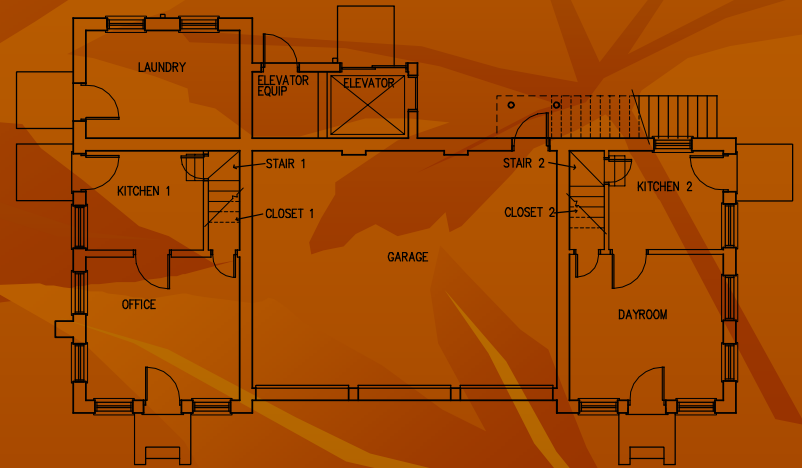
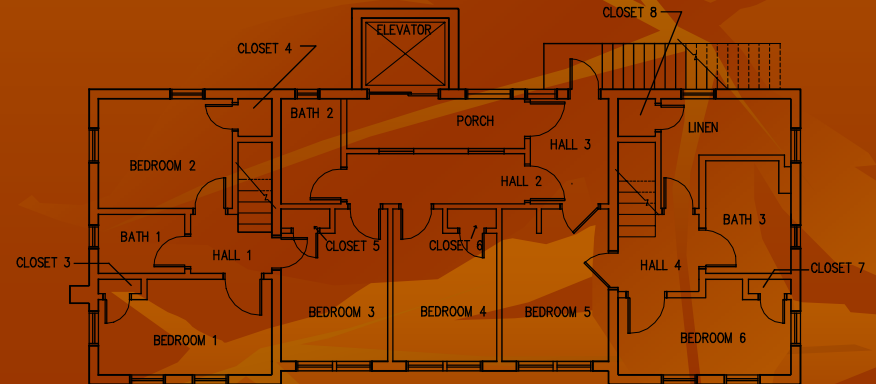
Condition Assessment

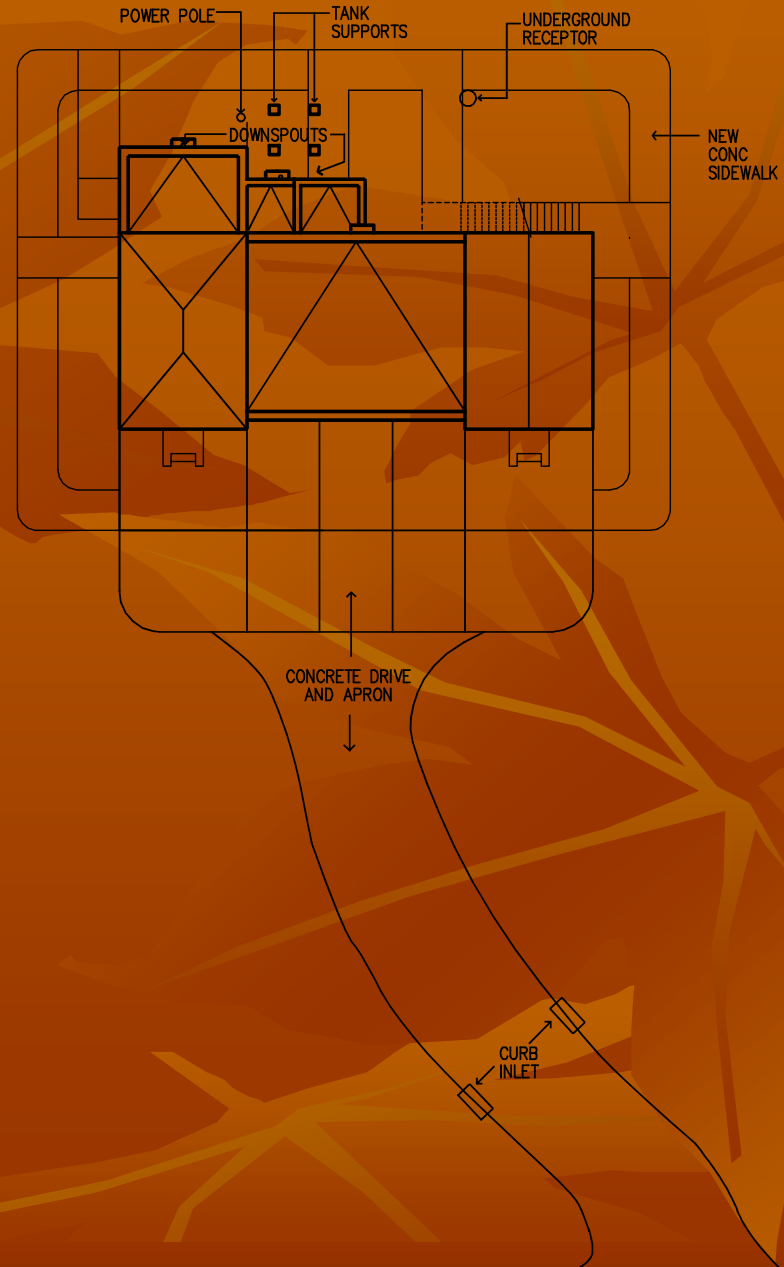
Condition Assessment

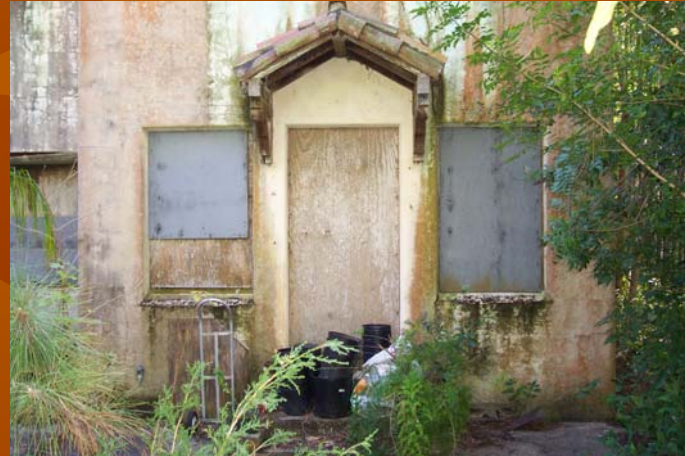
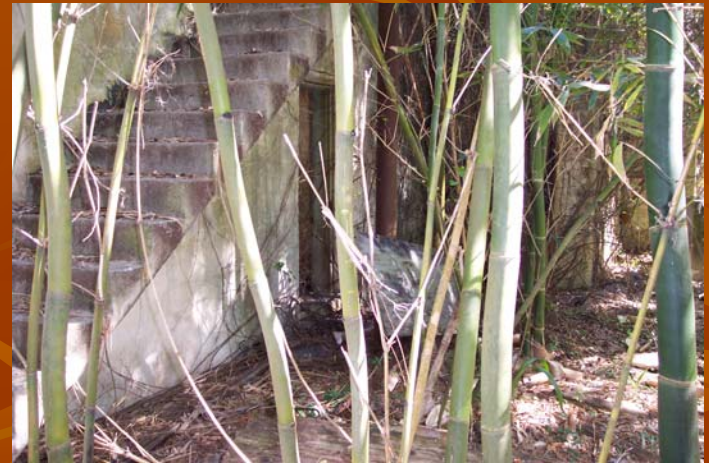
Condition Assessment

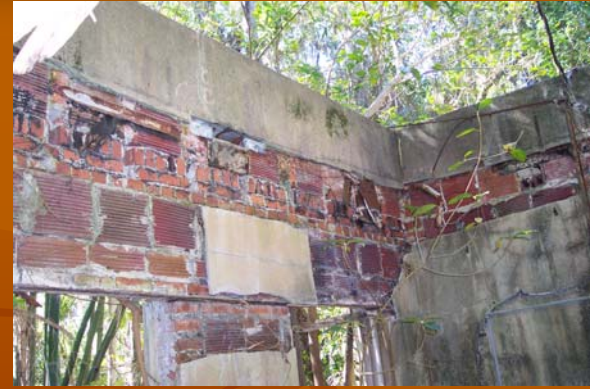
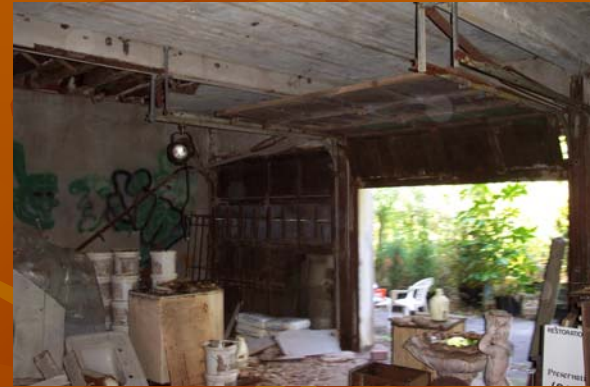
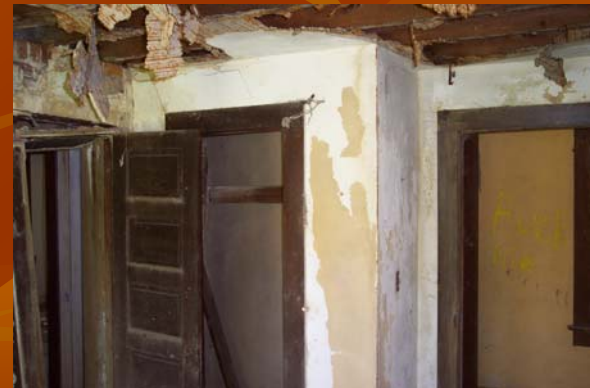
Condition Assessment

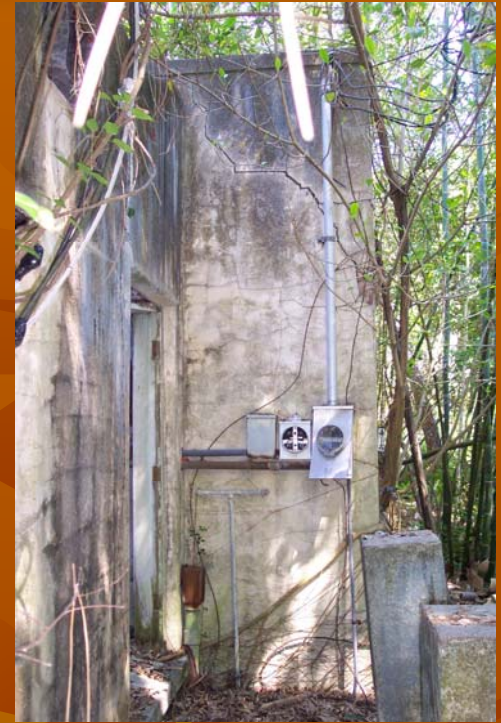
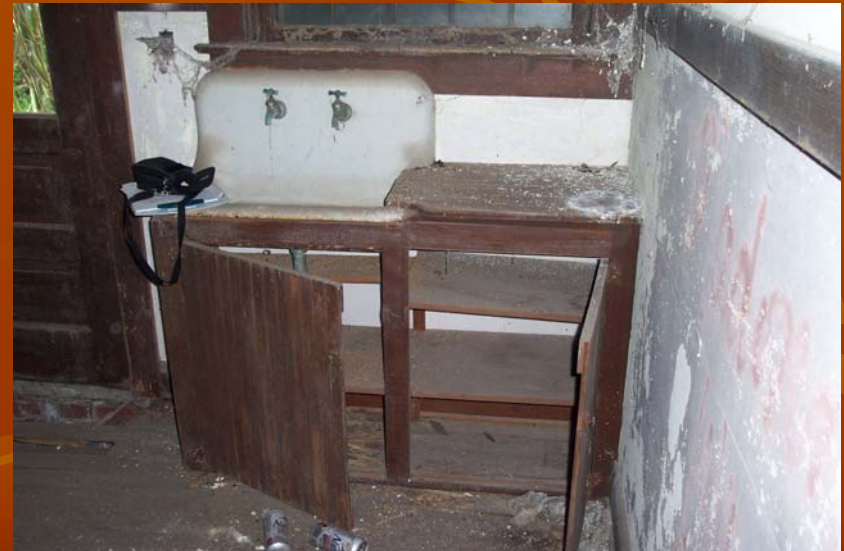
Exploring the Details

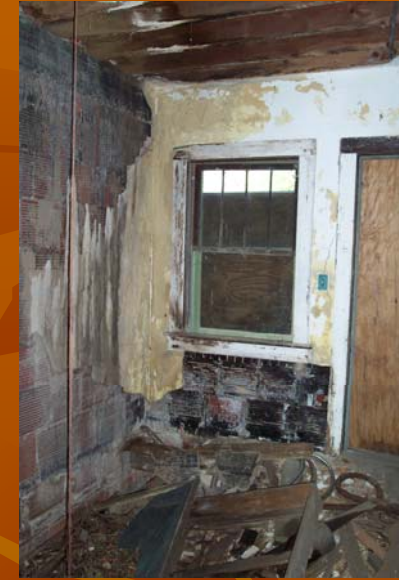
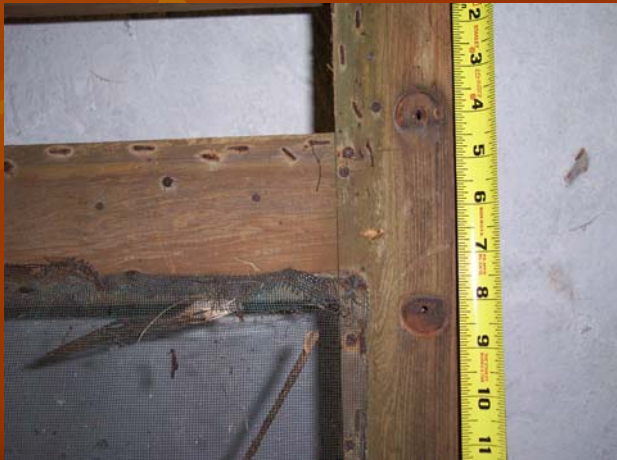
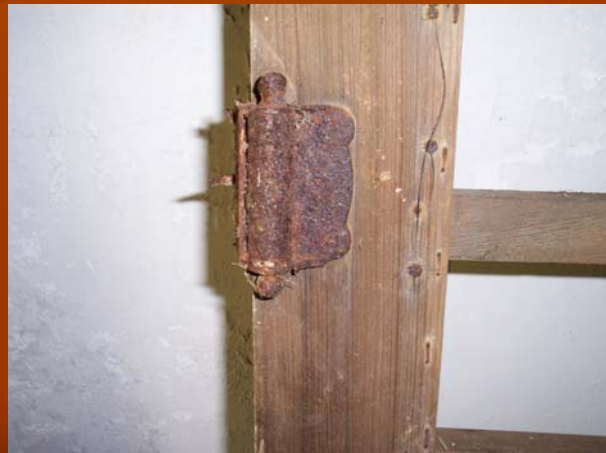
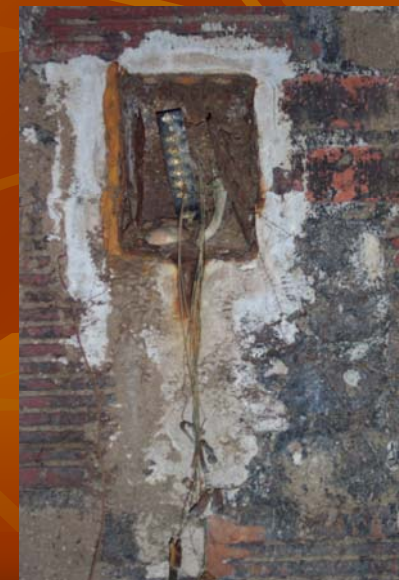
- Items to be restored or replaced are many and include:
 - Wood Trim and Moldings
 - Windows
 - Doors
- Finish, Door and Window Schedules in the Preservation Plan Report Detail the condition and suggested treatment for each item in every room
